**REPORT:** FE-22-97

**RAILROAD:** Metro North Commuter Railroad (MNCW)

**LOCATION:** Stamford, Connecticut

**DATE, TIME:** July 18, 1997, 1:29 a.m., EST

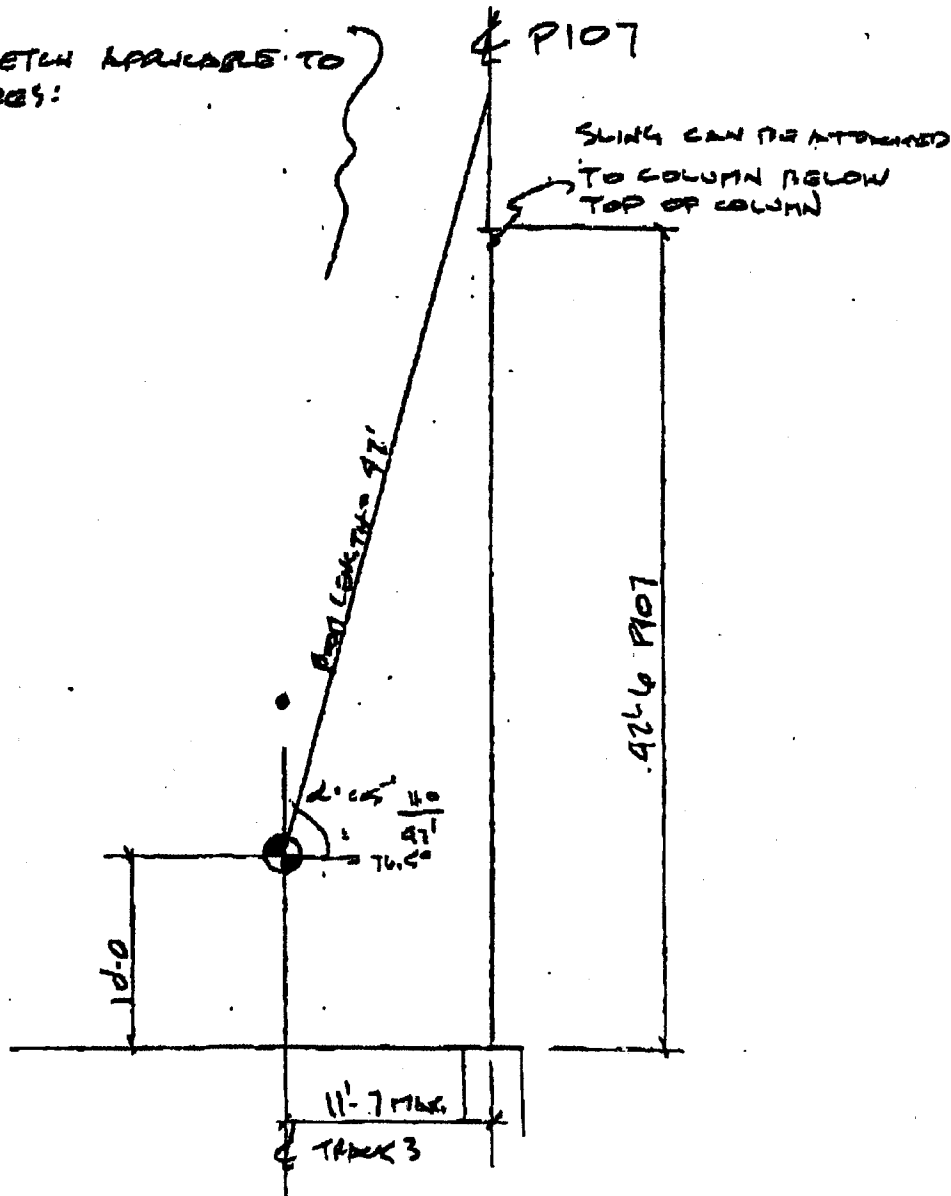
## TYPICAL ELEVATION FOR NEW PILES

THIS SKETCH APPLICABLE TO  
STRUCTURES:353 XA  
359 XA  
360 XA

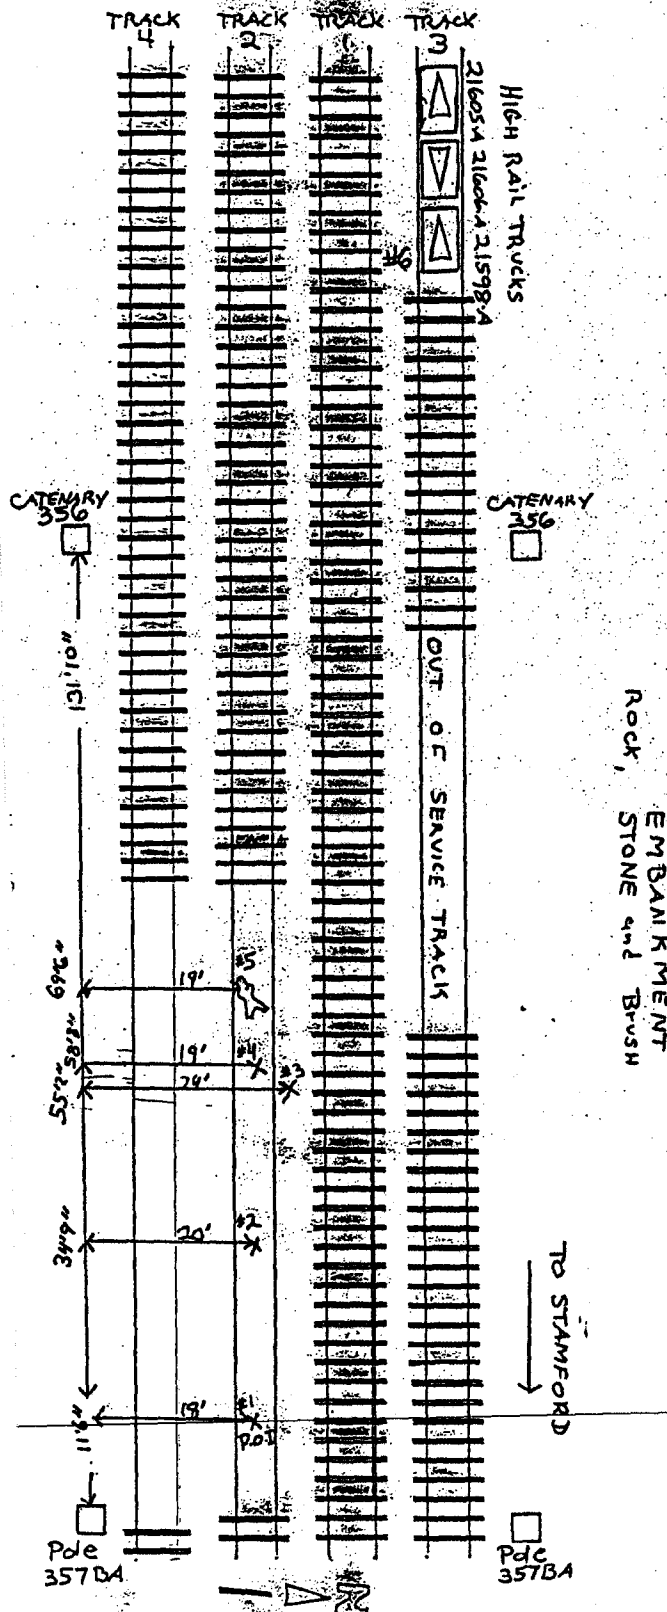
DAIGRAM KEY

- #1- Point of Impact. Approx. 11'6" WEST of Pole 357BA and approx. approx. 18 feet North of the track #4 SOUTH TIE end. Within the gauge of track #2.
- #2- Radio battery pack within the gauge of track #2 and approx. 34'9" WEST of Pole 357BA and approx 20' NORTH of the track #4 SOUTH TIE end.
- #3- Victims RIGHT arm between the track #1 and #2, approx. 55'2" WEST of Pole 357BA, and approx. 24' NORTH of the track #4 SOUTH TIE end.
- #4- Upper portion of a RRPCO radio approx. 58'8" WEST of Pole 357BA and approx 19 feet North of the Track #4 SOUTH TIE end, and within the gauge of track #2
- #5- Body of the victim within the Gauge of track #2, and approx. 69'6" from Pole 357BA and approx. 19' NORTH of the TRACK #4 SOUTH TIE end.
- #6- A RED baseball style cap located between track #1 and 3 approx 200 feet WEST of the point of impact.

A cross-over is present between tracks #2 and #1 in this area and has been deleted from this diagram.

Two additional highrail trucks are parked on track #3 to the EAST of 357BA and are not visable in this diagram.
